SUB-COMMITTEE ON DANGEROUS
GOODS, SOLID CARGOES AND
CONTAINERS
13th session
Agenda item 6

DSC 13/INF.7
2 July 2008
ENGLISH ONLY

CASUALTY AND INCIDENT REPORTS AND ANALYSIS

Toxic off-gassing of carbon monoxide and oxygen depletion during ocean transportation of pulp wood, wood chips and wood pellets

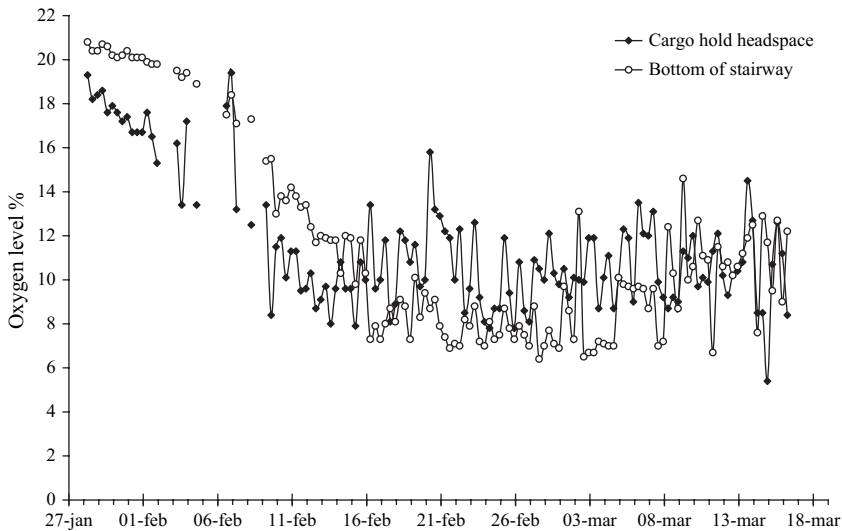
Fig. 3. The oxygen level in cargo hold headspace and bottom of stairway measured during ocean voyage (Vessel #4).

The results from the measurements aboard the vessels of oxygen at the bottom of the stairway and in the headspace of the cargo hold on Vessel #4 are described in Fig. 3. A steady state with ~10% oxygen level was reached after ~3 weeks at sea. The CO level in the headspace of the hold reached 900 ppm after 7 days. The onboard CO instrumentation was found to be unreliable over 1000 ppm and further evaluation of this parameter was not possible until the FTIR analysis was available at the time the cargo was discharged in the Port of Helsingborg.

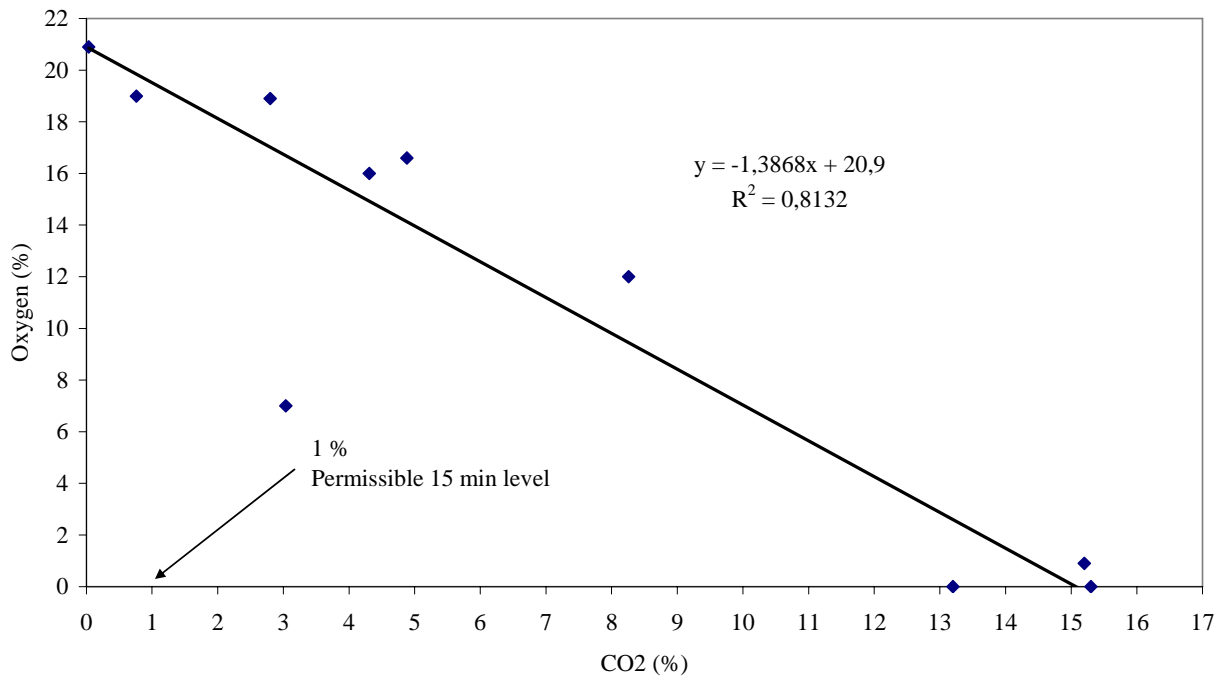
Figure 1. Oxygen content as a function of the CO2 level.

However, in the case of CO₂, the margin of safety is not very large as can be seen in Figure 1. By using the equation for the line of correlation, the permissible 15-min value of 1% CO₂ is reached when the oxygen level is as high as 19.5%. Although 1% CO₂ is not a dangerous level by itself, the combination effects with low oxygen content may constitute a hazard during prolonged stay in such an environment, particularly if the physical workload is heavy like climbing up and down stairways. The individual susceptibility to toxic gases can not be ignored.

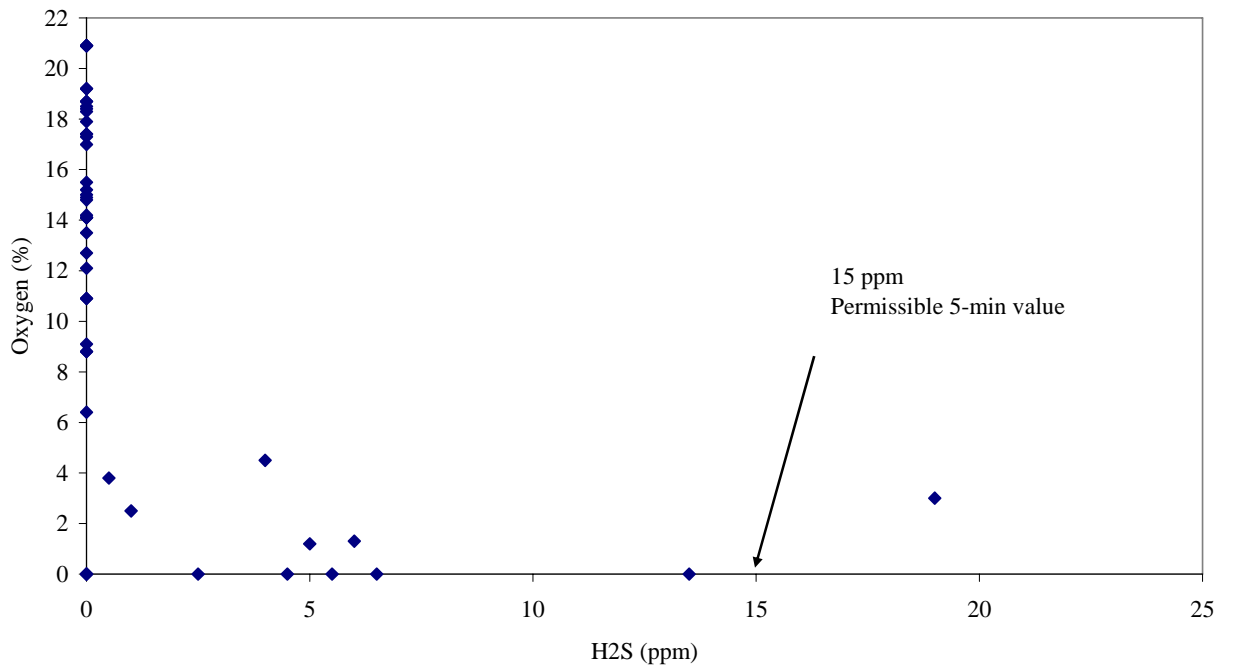
Figure 4. Oxygen vs. hydrogen sulfide

The levels of hydrogen sulfide were found to be below the acceptable 15-minute exposure of 15 ppm according to the Swedish Occupational Hygiene standards. Again these instances occurred when the oxygen level was below 5%, as can be seen in Figure 4.

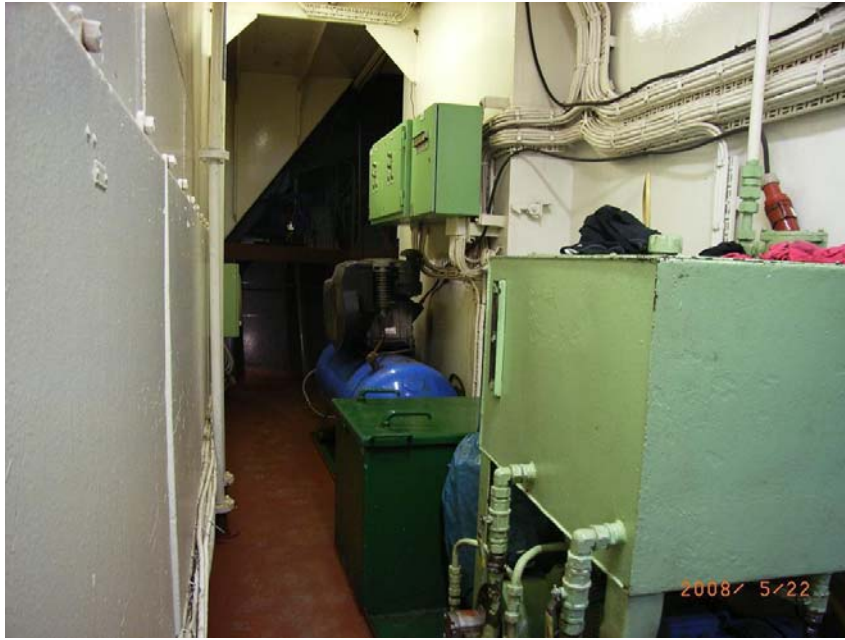
there was a compressor installed which may cause crew to enter for its operation. This is a dangerous design since it may very well be believed that the room does not have air communication with the hold. The room had the same oxygen level (14%) as the hold itself.

Photo 1. Confined entrance room with operating panels. The hold entrance door can be seen as the dark green box in the centre of picture

Many of the recommendations related to wood chips and pulp wood are the same as those we already have suggested for wood pellets and for a comprehensive discussion we refer to that publication (Svedberg et al, 2008). The simple advice is to always adhere to the safe entry procedures. The oxygen level should always be measured before entering a confined space with air communication with a cargo hold with wood chips and pulp wood or timber (roundwood). An oxygen meter should always be worn when inside a confined space. Unventilated air pockets inside the confined space may exist. Some confined spaces may appear to be sealed towards the hold, however, experience has shown that such spaces most often share the air with the cargo through minute openings.
