SUB-COMMITTEE ON DANGEROUS
GOODS, SOLID CARGOES AND
CONTAINERS
13th session
Agenda item 6

DSC 13/INF.7
2 July 2008
ENGLISH ONLY

CASUALTY AND INCIDENT REPORTS AND ANALYSIS

Toxic off-gassing of carbon monoxide and oxygen depletion during ocean transportation of pulp wood, wood chips and wood pellets

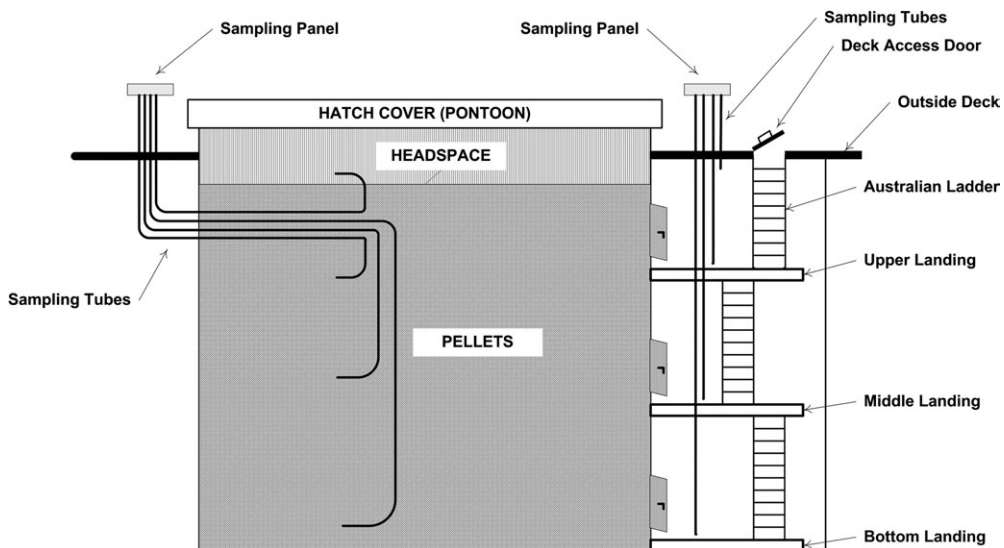
Fig. 1. Schematics of sampling points in the cargo hold and stairway on Vessel #4.

In an attempt to describe the dynamics of the off-gassing during the voyage, a system of sampling points was installed in one cargo hold and the respective stairway prior to the loading of Vessel #4, schematically outlined in Fig. 1. Sampling could thus be carried out from two sample panels without opening the deck-access door and hatch cover. Measurement of CO and oxygen were taken three times a day by the vessel's crew during the ocean transport, using a gas meter, model ATX620 (Industrial Scientific, Oakdale, PA, USA), equipped with an electrochemical sensor and calibrated with zero-gas (20.9% O₂ and 79.1% N₂) and 100 ppm CO.

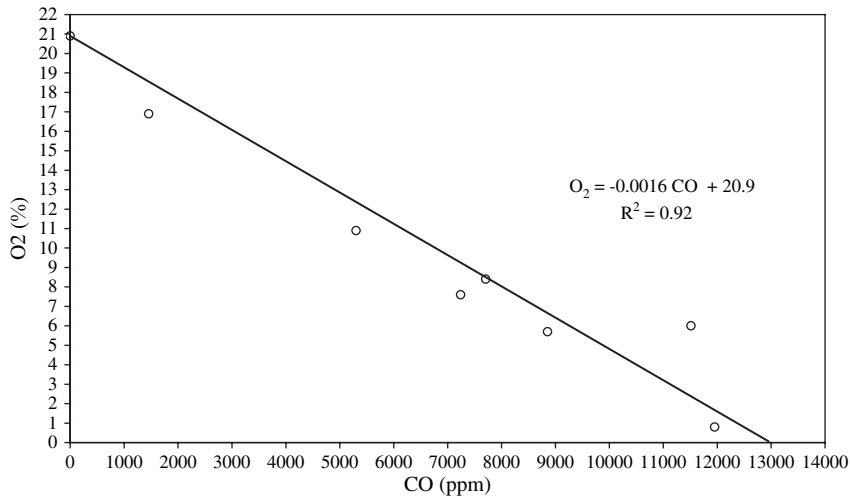
summarized in Table 1. Particularly notable are the high CO and CO₂ concentrations and the low oxygen levels. No indication of the presence of H₂S was seen. When the oxygen level from each vessel was plotted as function of the CO level, a high degree of correlation was obtained ($r^2 = 0.92$, see Fig. 2). Good correlation was also found between CO and butane equivalents ($r^2 = 0.93$) and CO₂ and propylene ($r^2 = 0.98$).

Fig. 2. The correlation between oxygen and CO concentrations in hatches and stairways. The point representing 20.9% oxygen and 0% CO is added manually.

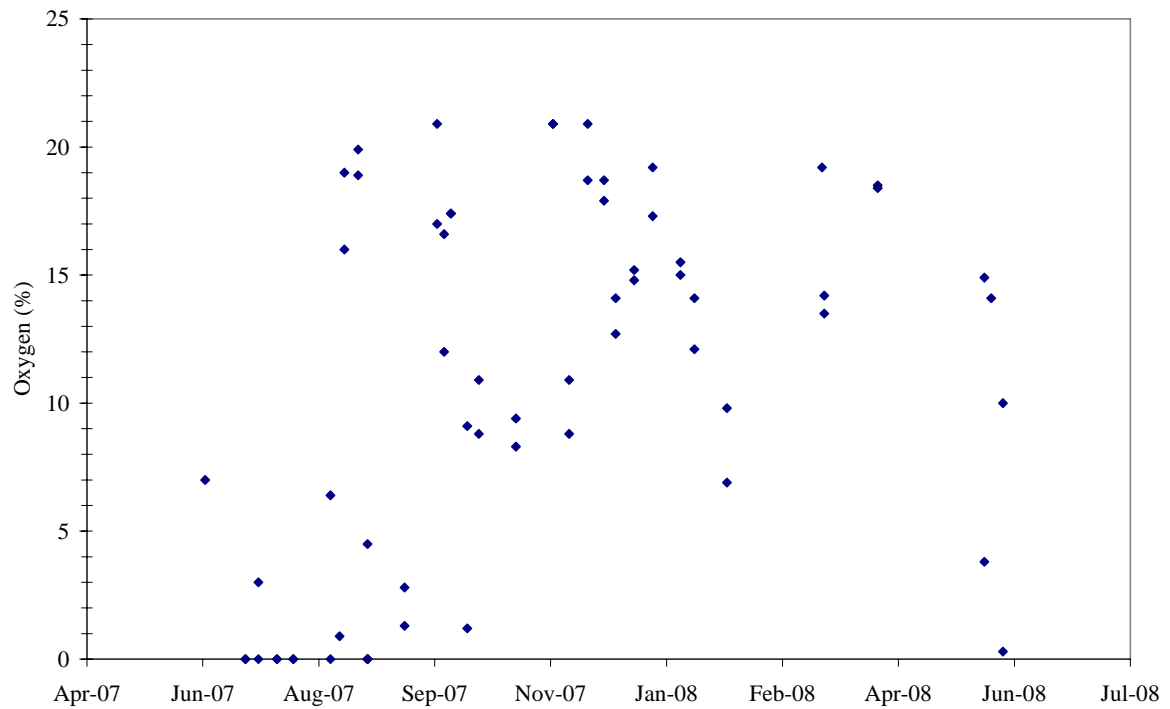
Figure 2. The seasonal variation of the final oxygen level in all sample positions on the investigated ships.

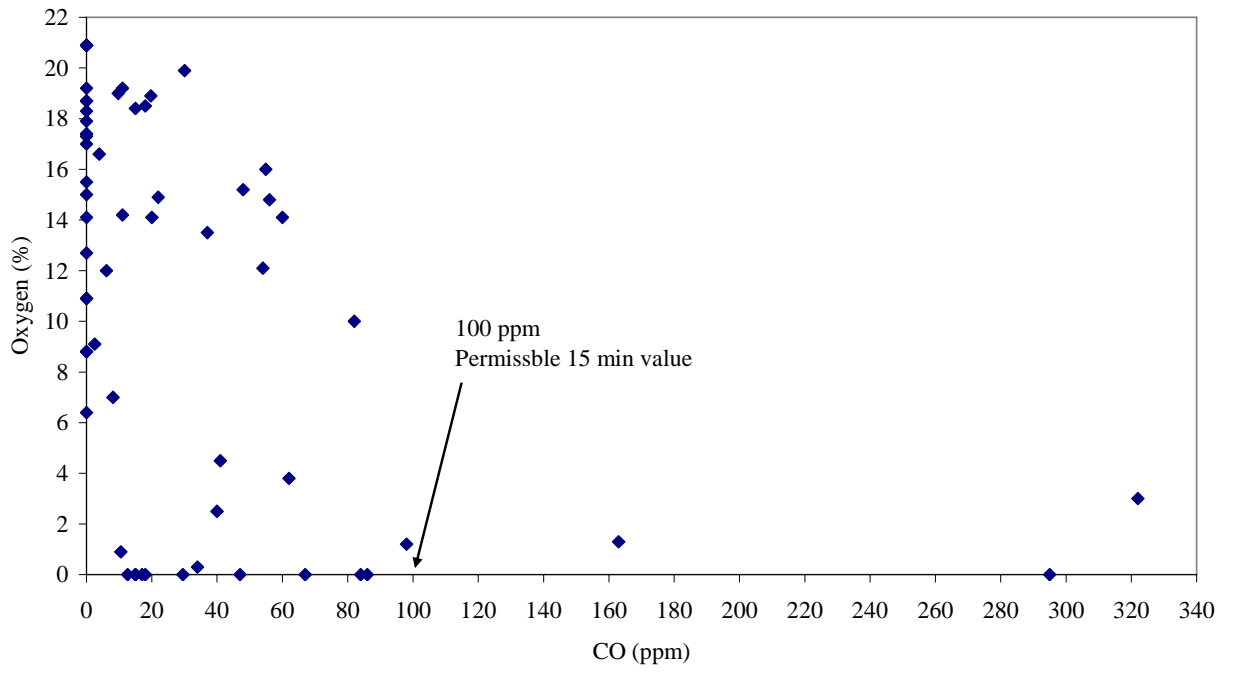
Figure 3. Oxygen vs CO content
